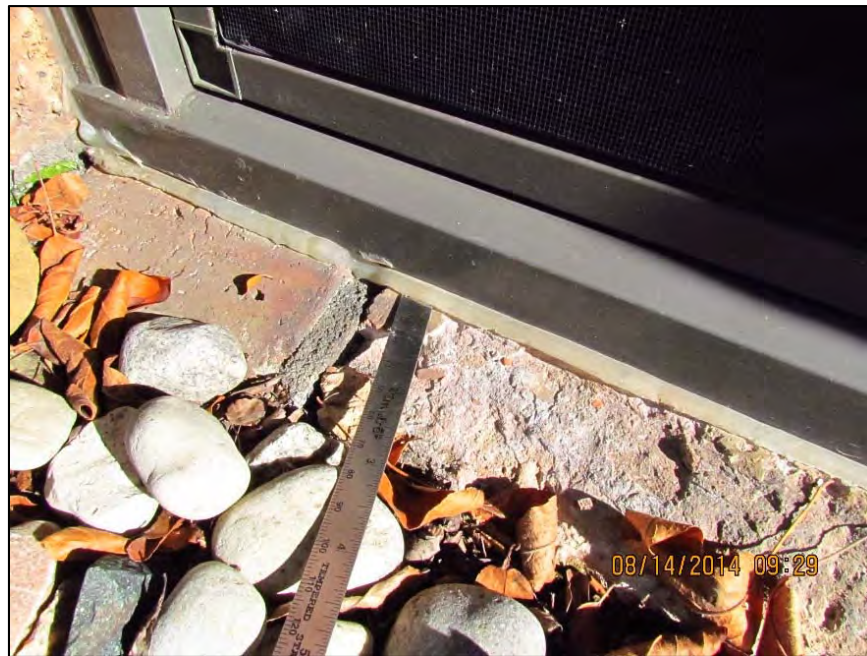
Figure 296

- e. The sills of the windows on the basement level are at or near grade level (Figure 293, 294, and 296), and on the front elevation, the grade slopes towards the window sills

- (Figure 296). Consequently, the sills of the basement windows are highly susceptible to ground water, and even if the brick rowlock sill below the windows has been flashed as required by the BIA, although it does not appear to be, the flashing could not drain as required since the flashing would be below grade. In addition, the window frame sill member at all these window frames is set directly onto the brick rowlock sill without any clearance as required by the BIA<sup>197</sup> and by the Kolbe installation instructions<sup>198</sup> (Figures 293, 294, 297 and 298). Because clay brick absorbs moisture, the sealant does not stop the flow of moisture through the brick and therefore the wood window frame that is in direct contact with the brick will be wetted.

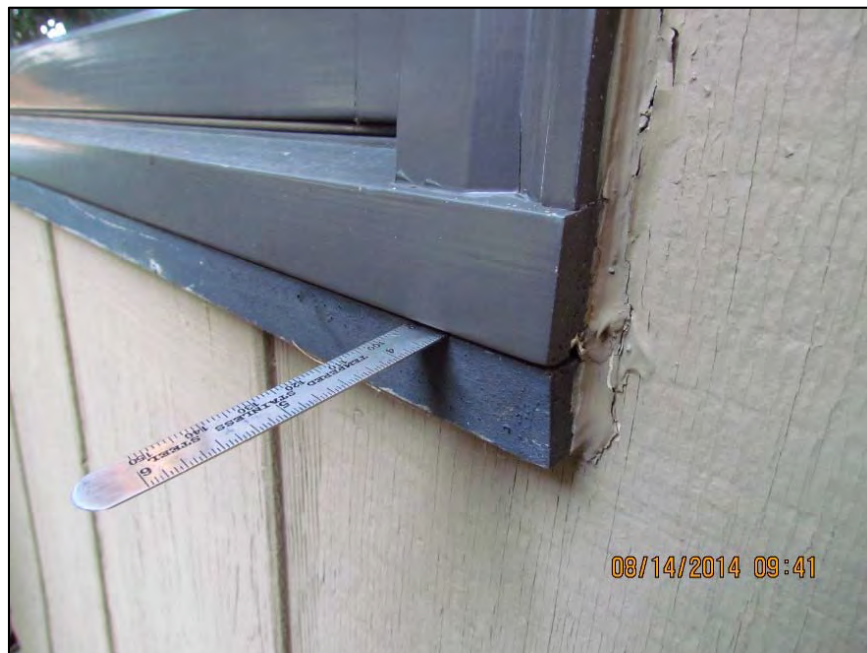
Figure 299

- f. A Kolbe window on the east elevation of the garage appears to have been installed on top of the original sill window trim, but it is not sealed to the old trim (Figure 299). The jamb brickmould trim is face sealed to the Texture 111 siding, but the sealant has failed (Figure 300). A drip cap is installed above the head brickmould, but it is reverse sloped (Figure 288). On the interior, no interior finishes are installed (Figure 301) and water stains are visible on the wall framing (Figures 302 and 303), but no stains are visible on the window frame joinery. No window wrap flashing or weather resistive barrier is installed into the rough opening (Figures 302 and 303). The opening was not properly filled or adjusted to fit the window, so there are large gaps between the window frame and the wall framing (Figure 304), but no shims or frame anchors are visible as required by the Kolbe installation instructions<sup>199</sup> (Figures 302, 303, and 304). The inward facing side of the brickmould is visible in these gaps, and no sealant was installed at the brickmould-to-window frame joint as is required by the Kolbe installation instructions<sup>200</sup> (Figure 304). No sealant ooze-out is visible at the edge of the brickmould where it laps over the sheathing as would be expected had sealant been installed prior to installation of the window (Figures 302 and 304).

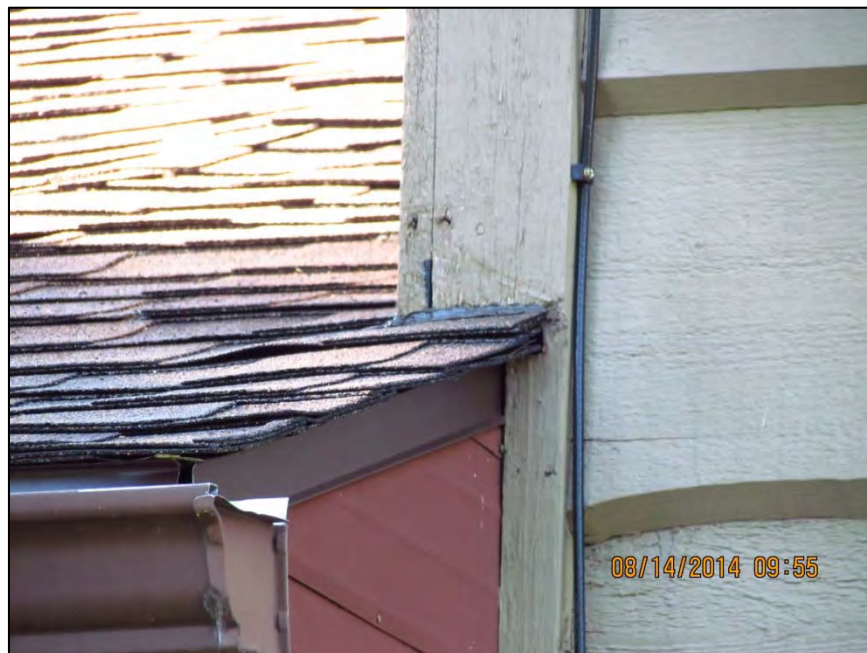
Figure 310

- a. No flashing is visible at roof-to-wall terminations. Instead, the siding is caulked to the roofing shingles (Figures 309 and 310).
- b. No kick-out flashing is installed at the bottom end of roof-to-wall terminations (Figures 309 and 310).
- c. Unlike the Kolbe windows, the non-Kolbe window and patio door on the rear elevation were installed with raised trim surrounds that was clad with aluminum (Figure 311) and the cladding trim was fully sealed to the surrounding wall siding.

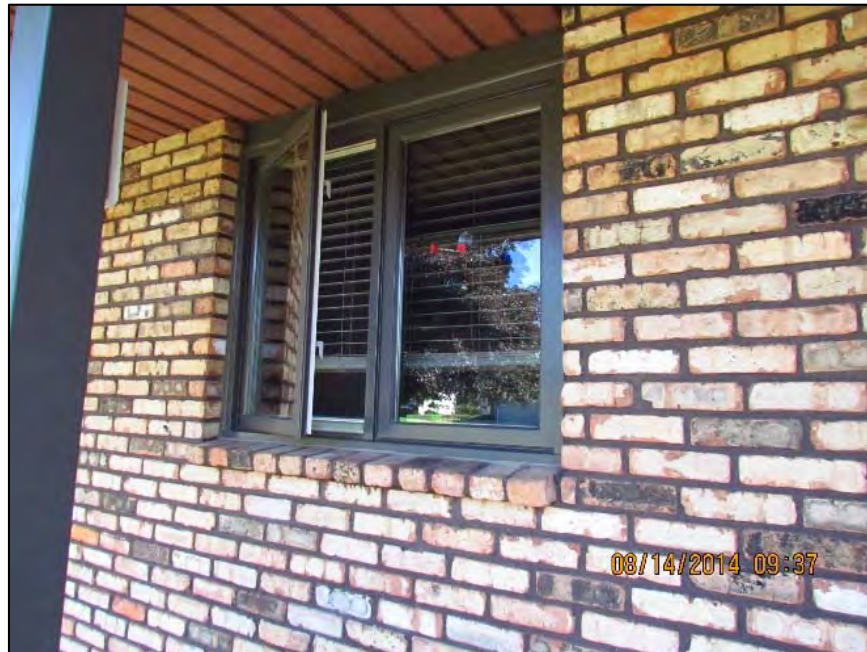
Figure 312

8.6.6 On January 12, 2015, Exponent performed field air infiltration testing of one window, and field water infiltration testing of two windows. The windows tested were a twin vent casement window on the south elevation in the Kitchen (Figure 312) and a double hung window on the north elevation in the Master Bedroom (Figure 313). For the purposes of this report, these are identified as McIver Specimens A and B respectively. GCI's observations of this work were as follows:

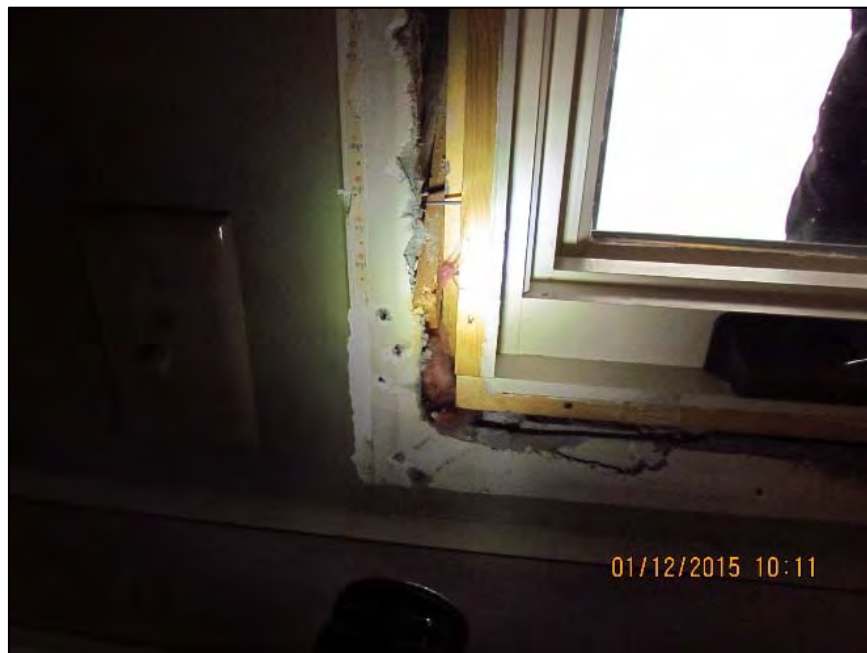
Figure 314

- a. At McIver Specimen A, no water stains were visible on the window sashes, frames, or on the wood framing around the window opening (Figure 314), however, upon removal of insulation from above the head of the window, condensation moisture was found on the insulation above the head of the window and on the back of the brickmould trim (Figure 315). The window was installed approximately  $\frac{1}{8}$ " out of square. At McIver Specimen B, the exterior sealant has failed (Figure 316 and 317) and the head drip is reverse sloped (Figure 317). The sill is not sealed to the siding (Figure 318) and there is visible degradation of the brickmould trim at the jamb on the east side of the window

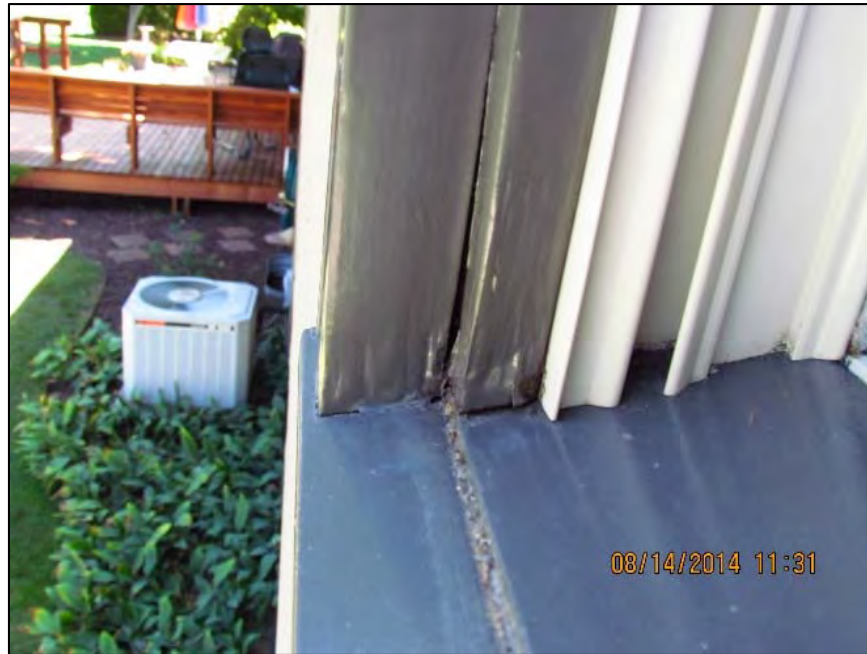
Figure 319

(Figure 319). The window was not installed plumb.<sup>201</sup>

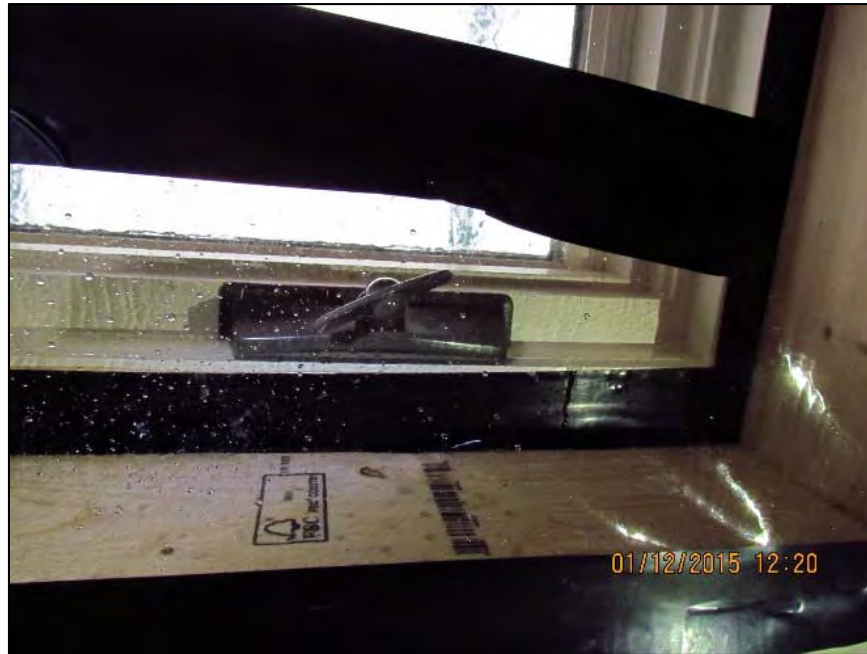
Figure 321

- 2) McIver Specimen A revealed no water leakage in the first at 0 p.s.f. or the second test at approximately 1.9 p.s.f. ( $\pm 27.2$  mph). During the third test at a static air pressure 5.0 p.s.f. ( $\pm 44.2$  mph), water appeared around the casement operators, on top of the window sill member (Figures 321 and 322) approximately 9 minutes after the start of testing. As previously noted, no staining of any sort was present prior to testing that would indicate leakage had ever occurred in this manner at this window before, and the owner, who was present, did not indicate that leakage had occurred at this window in the past. Observations revealed that the volume of water present on the frame sill at the conclusion of the first and second tests was not enough to pool atop the sill but left only intermittently dispersed areas of water approximately 1 to 2 mm deep, and almost no water was on the underside of the sash (Figures 323 and 324). At the conclusion of the third test, when the window leakage was induced because of the elevated pressure, moisture seeped inward of the frame gasket which allowed entry around the rotary operator, but even then, the

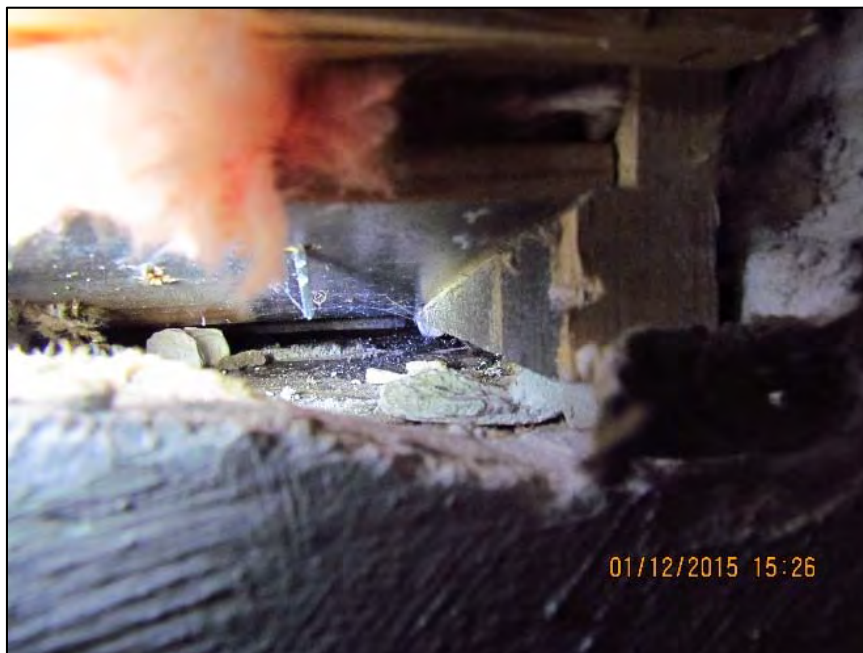
Figure 325

water that had collected atop the flat portion of the window sill was only intermittently dispersed areas of water droplets approximately 1 to 2 mm deep (Figure 325).

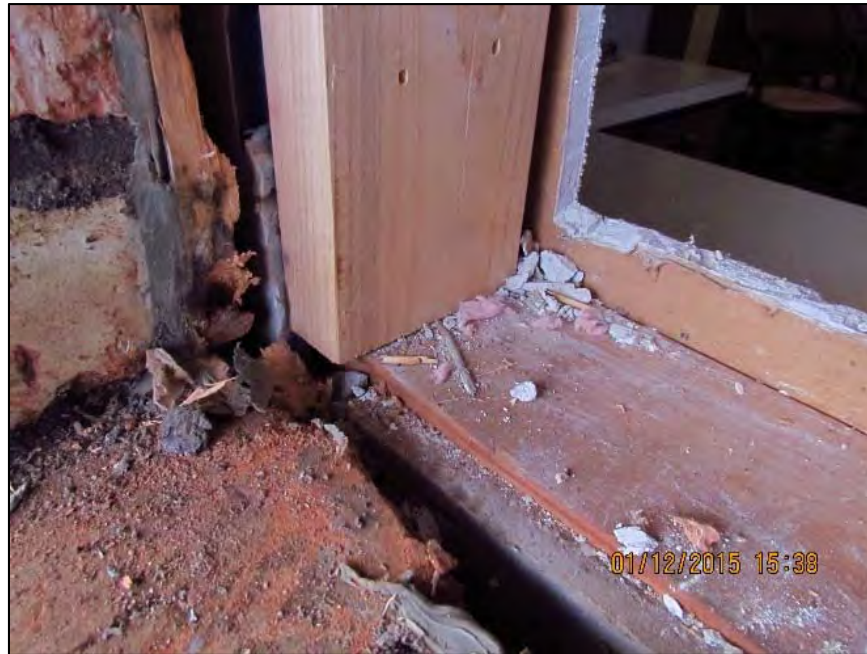
Figure 327

- 3) No weather resistive barrier or flashing tape was used to flash the rough opening (Figure 327).
- 4) 2" x 4" framing lumber was added at the jambs and head to fill in the original rough opening to fit the Kolbe window, but the sill framing appears to be original since it is approximately level with the brick sill, and there is no evidence the row lock sill was replaced. There is no staining on any of the framing lumber except at the east end of the sill towards the exterior edge (Figure 328), but since the sill member is original, and because of the test results, this may pre-date installation of the Kolbe windows.

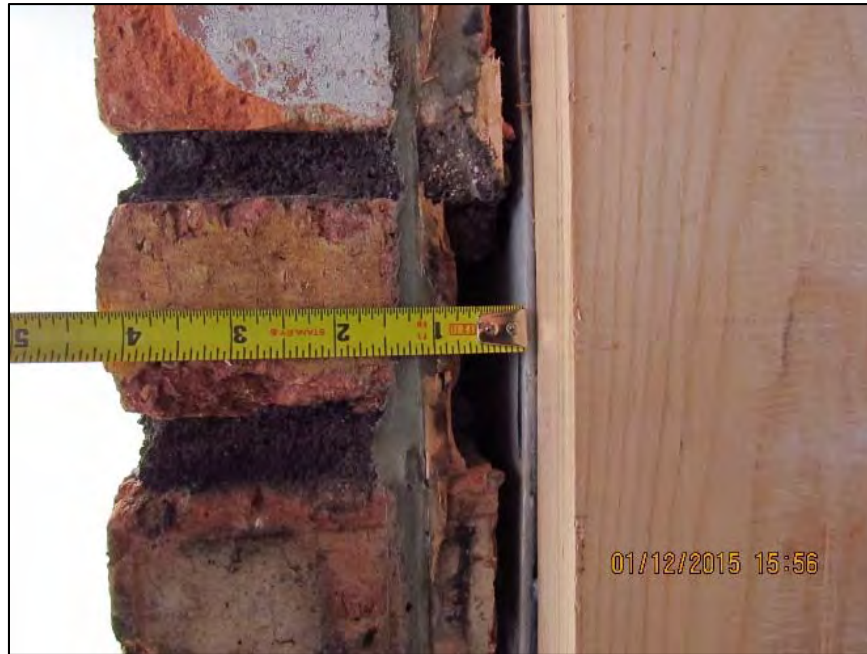
Figure 329

approximately  $\frac{3}{4}$ " wide rather than the 1" minimum dimension as recommended by the BIA<sup>212</sup> (Figure 329).

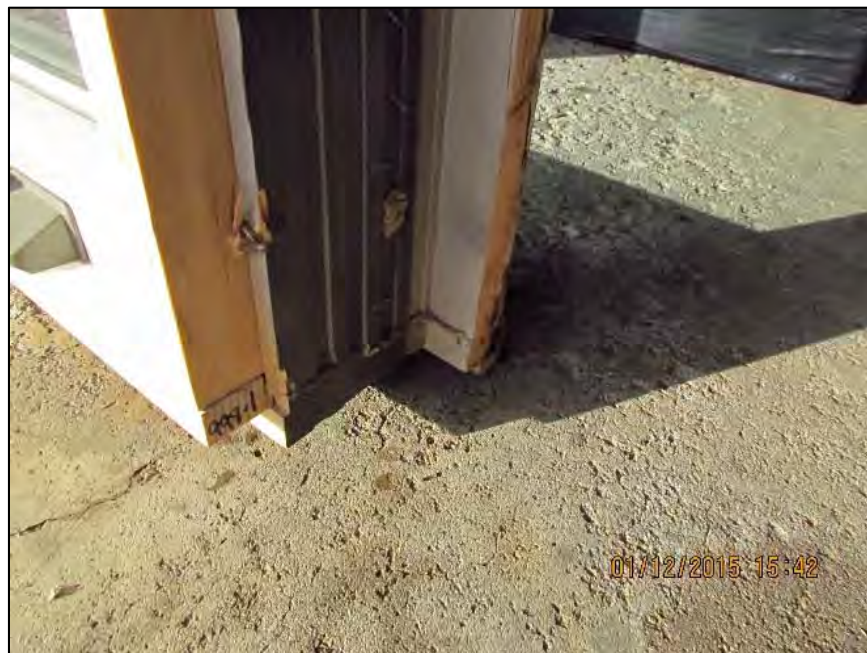
Figure 330

- 7) The Kolbe installation instructions require sealant on the inward side of brickmould where it joins onto window frame.<sup>213</sup> The sealant was not installed (Figures 330).
- 8) The Kolbe installation instructions require that the sealant on the inward side of brickmould is to seal the top of the jamb brickmould to the head brickmould and to the bottom of the jamb brickmould to the sill horn.<sup>214</sup> The sealant was not installed (Figures 330).
- 9) There is no water staining or deterioration on the window frames, sashes, or window frame joinery to indicate that leakage has occurred in the past (Figure 330), including the area where leakage was created during the third test. Further, there is no staining or deterioration of the window frame sill member or the bottom of the sashes that corresponds to the design defect allegations outlined in Exponent report.

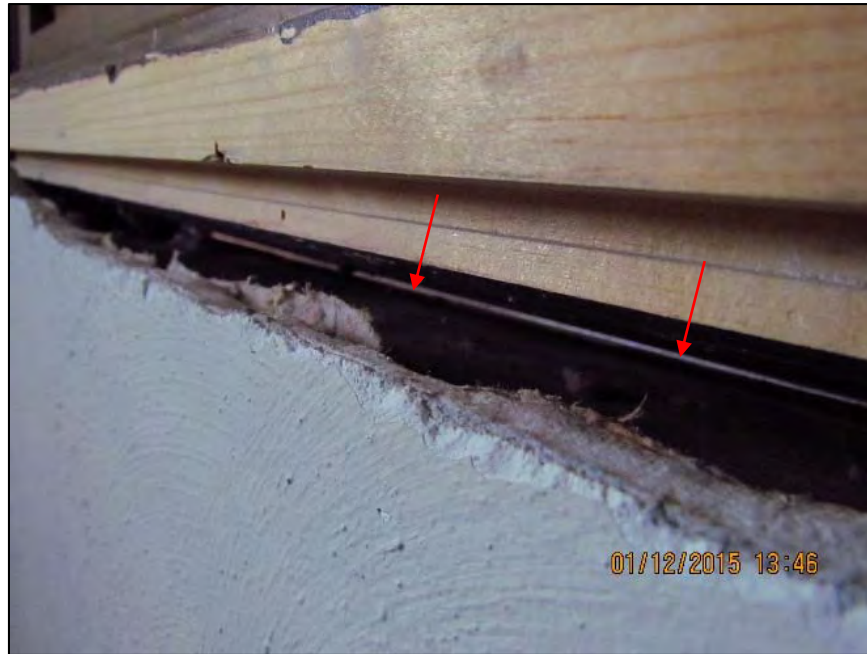
Figure 331

- 1) Prior to removal of the window, observations from the interior revealed that daylight is visible between bottom of the window sill and the top of the rough opening (Figure 331) revealing the required sealant was missing or it was improperly installed.
- 2) The window frame was attached to the structure only using finishing nails. No frame clips, jamb screws, or nails through the brickmould trim were provided.
- 3) No shims were installed between at the between the window frame and the rough opening as required by the Kolbe installation instructions.<sup>215</sup>
- 4) No weather resistive barrier or flashing tape was used to flash the rough opening (Figure 332).
- 5) The rough opening framing lumber appears to be original. There is staining on

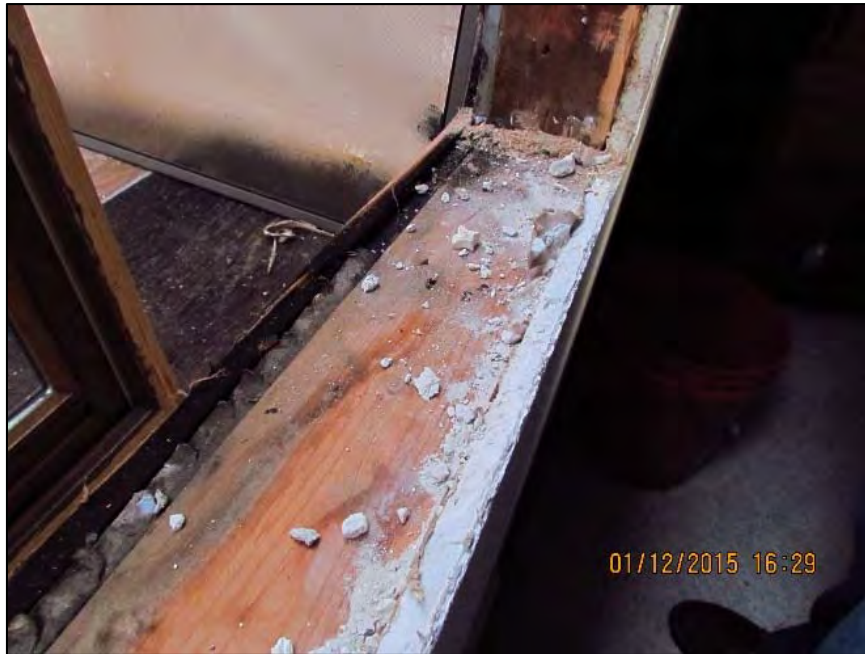
Figure 333

framing along the outer edge and at the east end of the opening (Figure 333).

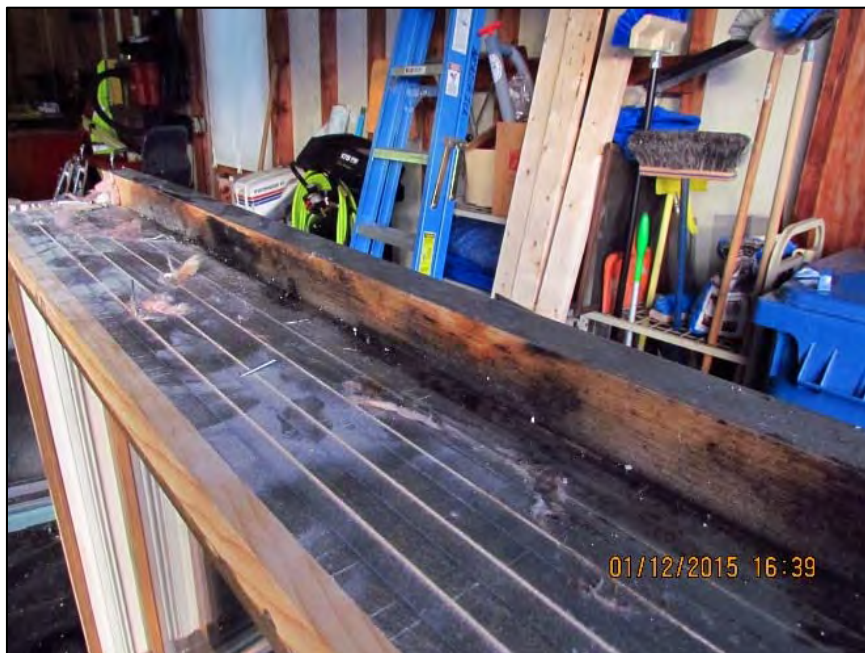
Figure 334

- 7) The Kolbe installation instructions require sealant on the inward side of brickmould where the brickmould joins onto window frame.<sup>217</sup> This sealant was not installed (Figures 334, 335 and 336).

- 9) There is staining on the top of the window frame head and on the back of the head brickmould indicating the water enters above the window (Figure 334). The staining continues across the head to the east side (Figure 335) and then down the east jamb to the bottom of the brickmould jamb trim (Figure 336).

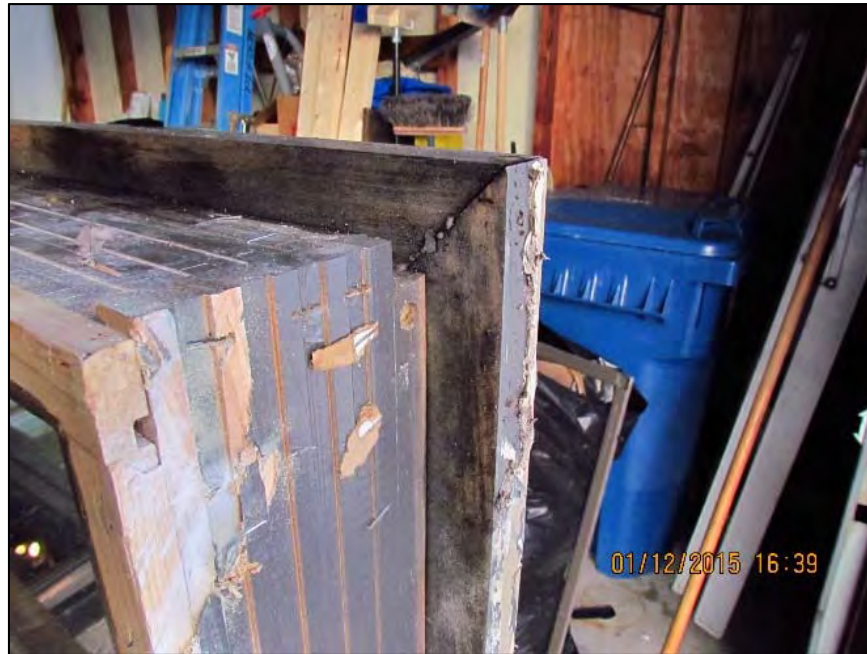
Figure 335

- 8) The Kolbe installation instructions require that the sealant on the inward side of brickmould is to seal the top of the jamb brickmould to the head brickmould and to the bottom of the jamb brickmould to the sill horn.<sup>218</sup> The sealant was not installed (Figures 335 and 336).

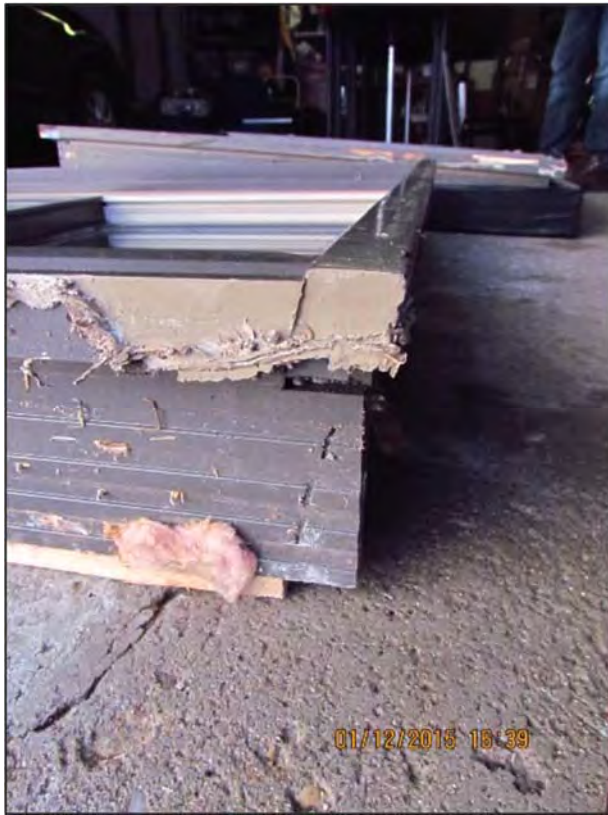
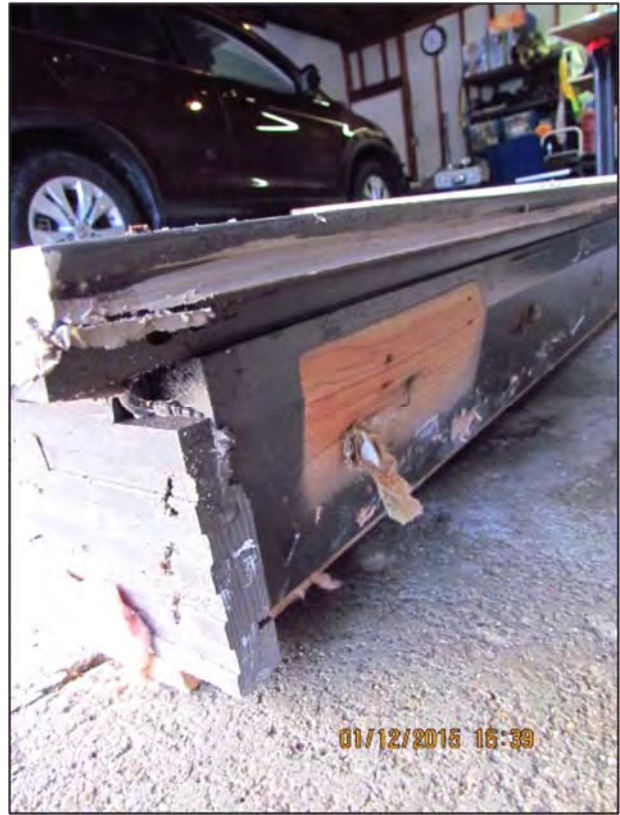
- 9) There is no water staining or deterioration on the window frames, sashes, or window frame joinery, including the east end of the sill, that would indicate leakage entered through the window (Figures 337 and 338).
